Evaluation of Fish Entrainment in 12 Unscreened Sacramento River Diversions

Final Report

July 2013

Prepared by:
Dave Vogel
Natural Resource Scientists, Inc.
P.O. Box 1210
Red Bluff, CA 96080

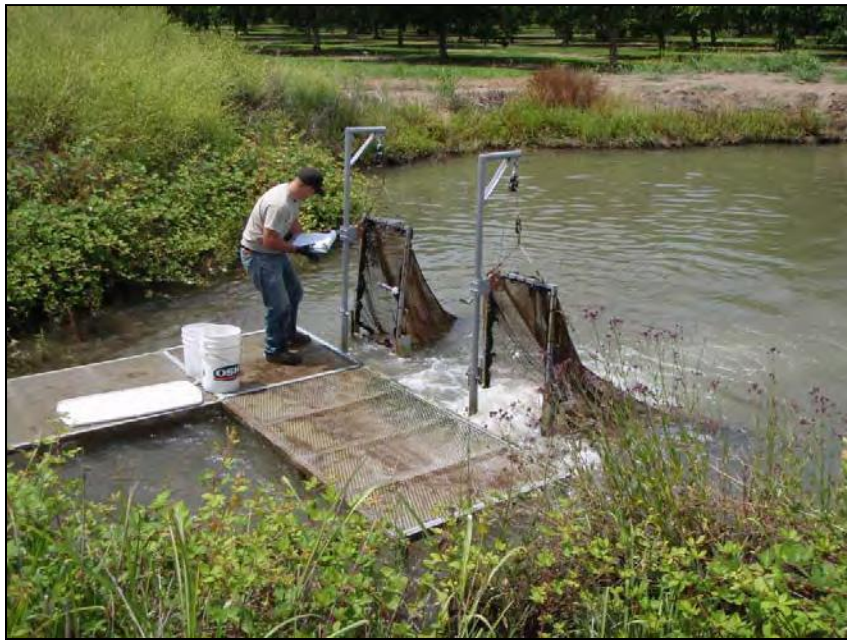
Figure 2. Fyke apparatus and nets used to sample for fish entrainment at the Sycamore canal.

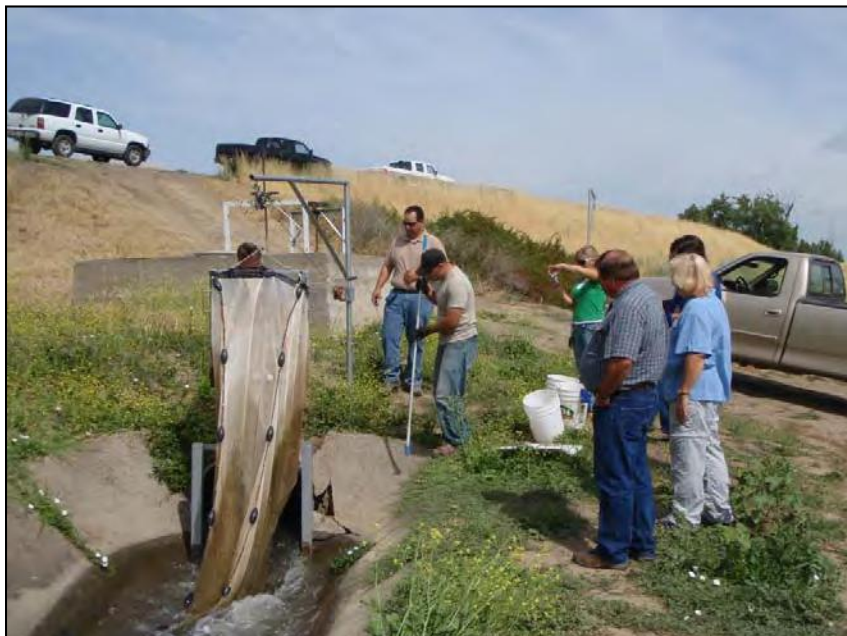
Figure 3. Fyke apparatus and net used to sample for fish entrainment in one of two canals at River Garden Farms No. 2.

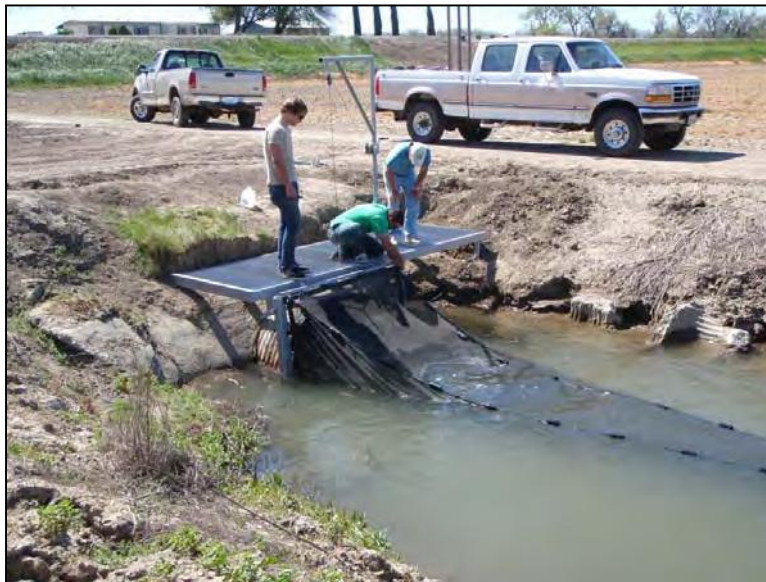
Figure 4. Fyke apparatus, fyke net, and sampling platform used to sample for fish entrainment in the State Ranch canal.

The fyke apparatus at State Ranch consisted of a 5-ft by 5-ft 10-inch rectangular metal frame and a 5-ft by 5-ft 10-inch by 20-ft long ¼-inch knotless nylon mesh fyke net. The end of the fyke net tapered to a 1-ft by 1-ft, by 3-ft long 3/16-inch knotless nylon mesh bag and a Velcro® zippered end to remove fish and debris. The fyke frame and net were raised and lowered within a 3-inch metal channel frame using a winch to check for fish entrapment each day (Figure 4). We estimated that the fyke net captured approximately 90% of the fish entrained into the canal when the net frame fully covered the culvert opening. In some instances early in the season when debris loads were exceptionally high, the net frame covered approximately half the submerged opening of the culvert and an estimated half of the flow was sampled. In these latter instances, fish catches were expanded to account for the un-sampled flow.

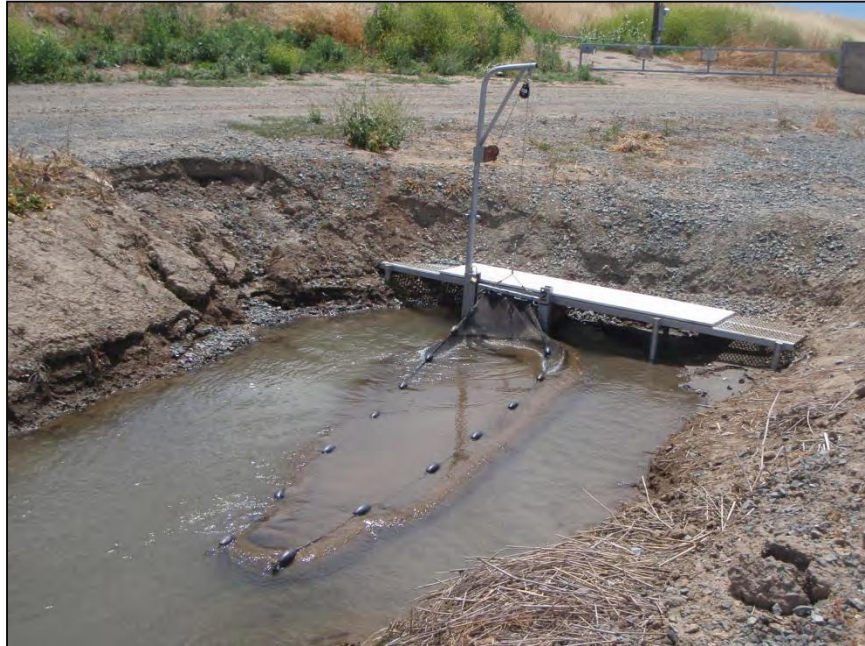
Figure 5. Fyke apparatus, fyke net, and sampling platform used to sample for fish entrainment in the South Steiner earth canal.

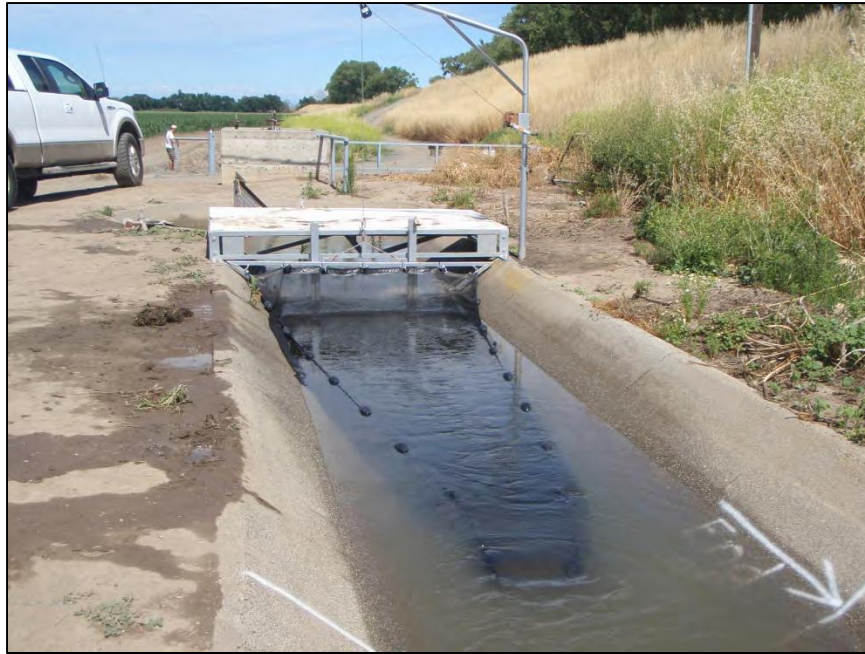
Figure 6. Fyke apparatus and sampling platform used for fish entrainment sampling in the South Steiner concrete canal.

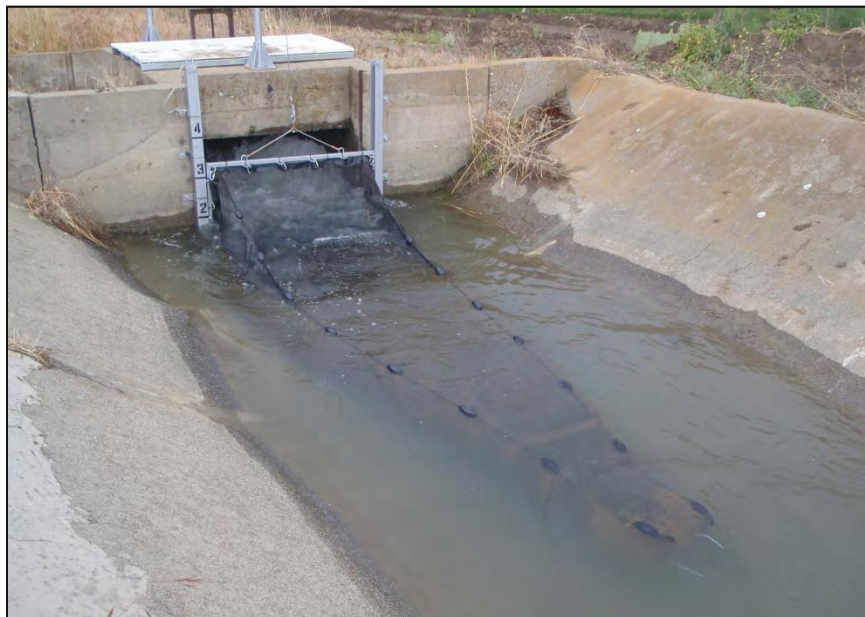
Figure 8. Fyke apparatus, fyke net, and sampling platform used to sample for fish entrainment in the Windswept canal.

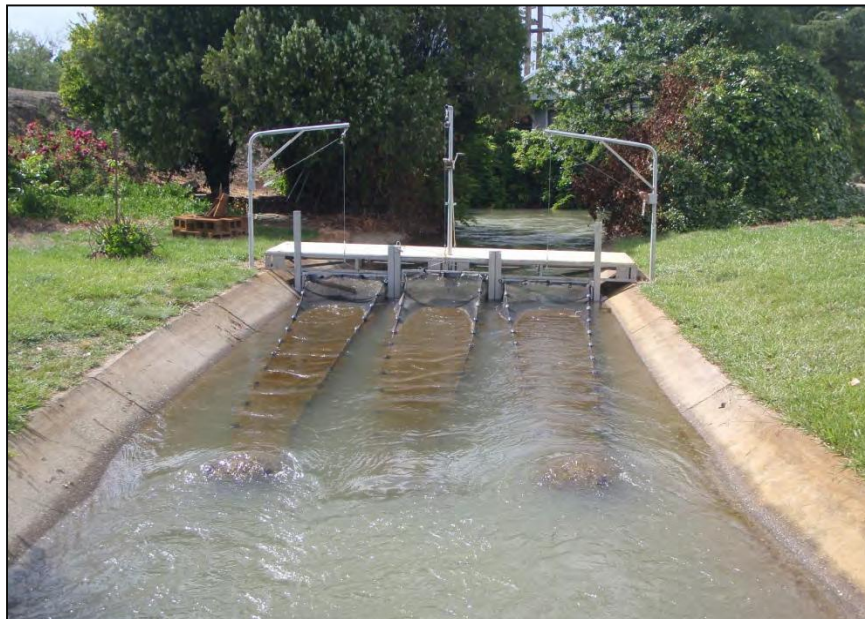
Figure 9. Three fyke nets, sampling platform, and associated apparatus used to sample for fish entrainment in the Portuguese Bend canal.

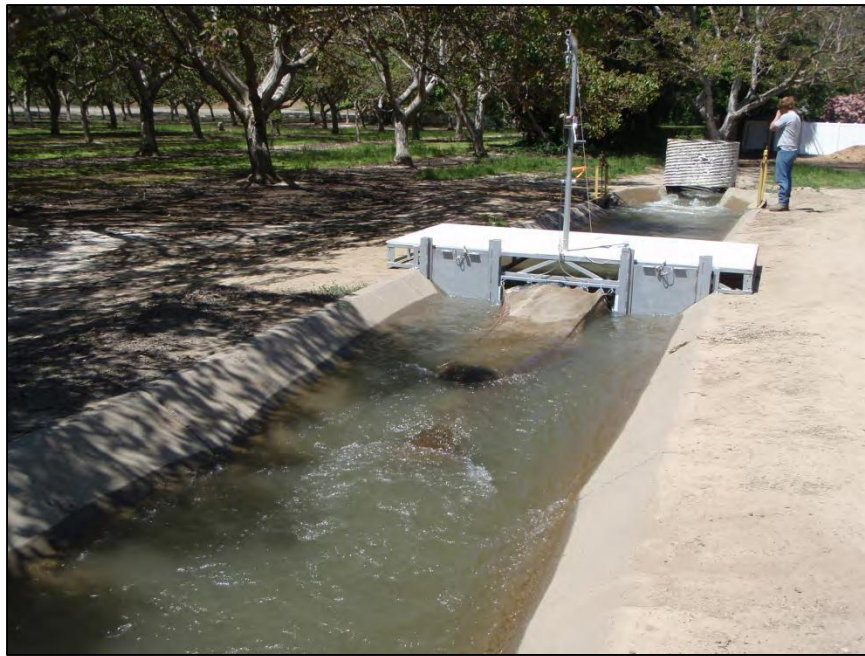
Figure 10. The fyke net, sampling platform, and associated apparatus used to sample for fish entrapment in the Alamo trapezoidal concrete canal.

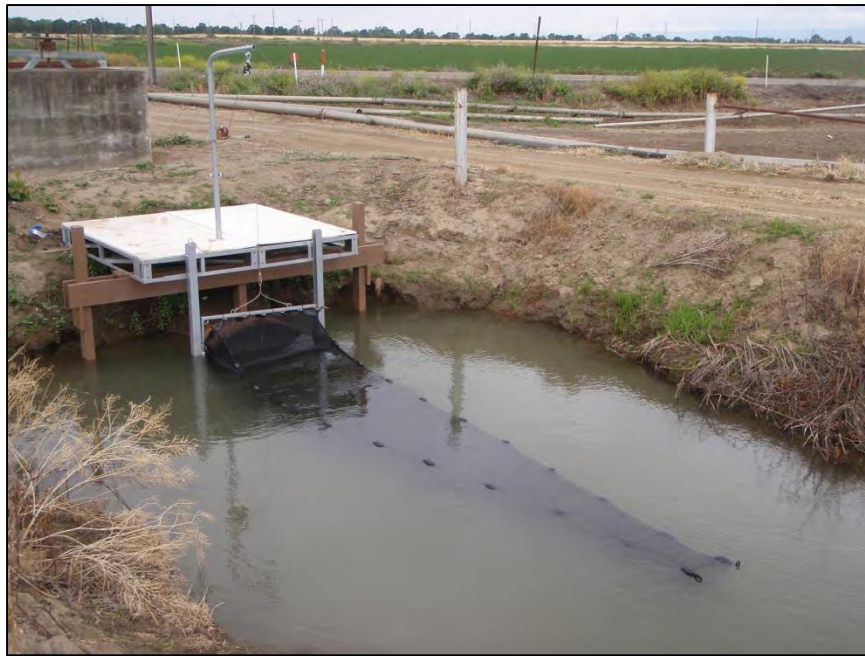
Figure 10. The fyke net, sampling platform, and associated apparatus used to sample for fish entrainment in the Townsite north canal.

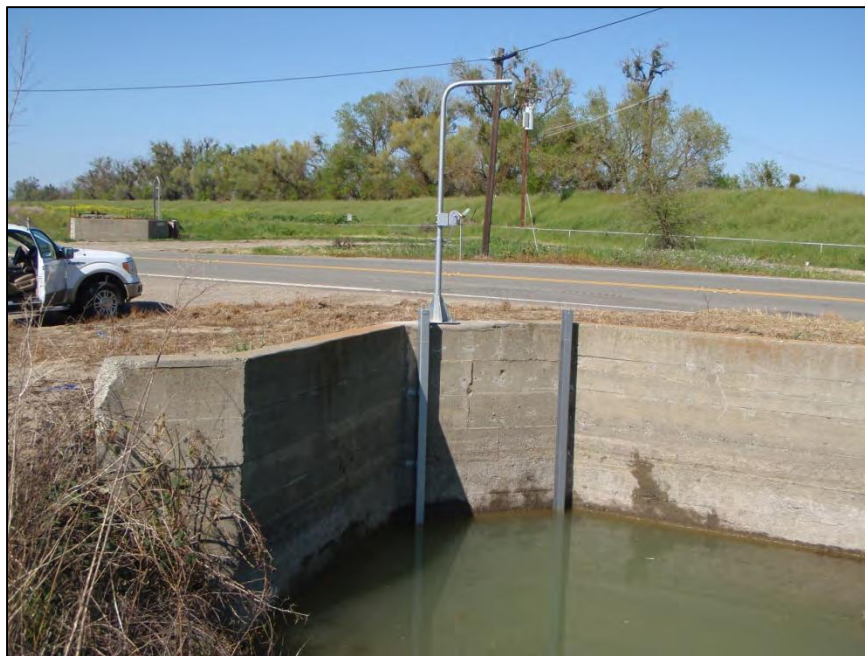
Figure 11. The fyke apparatus used to sample for fish entrainment in the Townsite south canal.

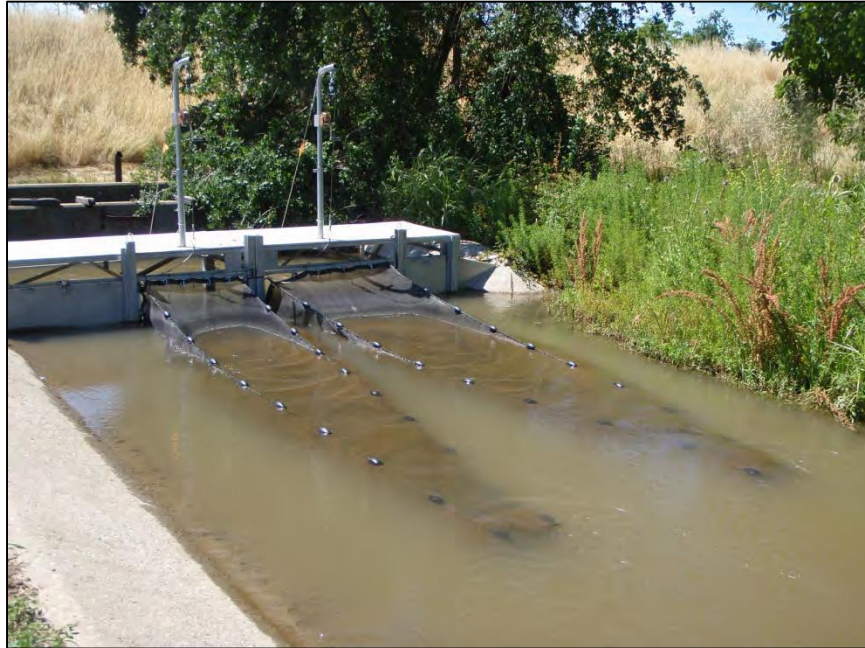
Figure 12. Two fyke nets, sampling platform, and associated apparatus used to sample for fish entrainment in the Tisdale canal.

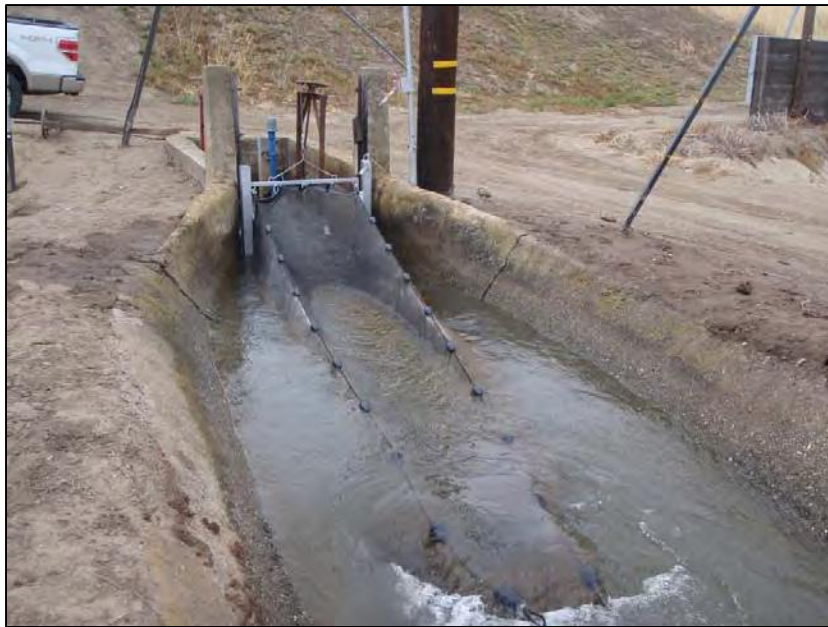
Figure 13. The fyke net and associated apparatus used to sample for fish entrainment in the Cranmore trapezoidal concrete canal.

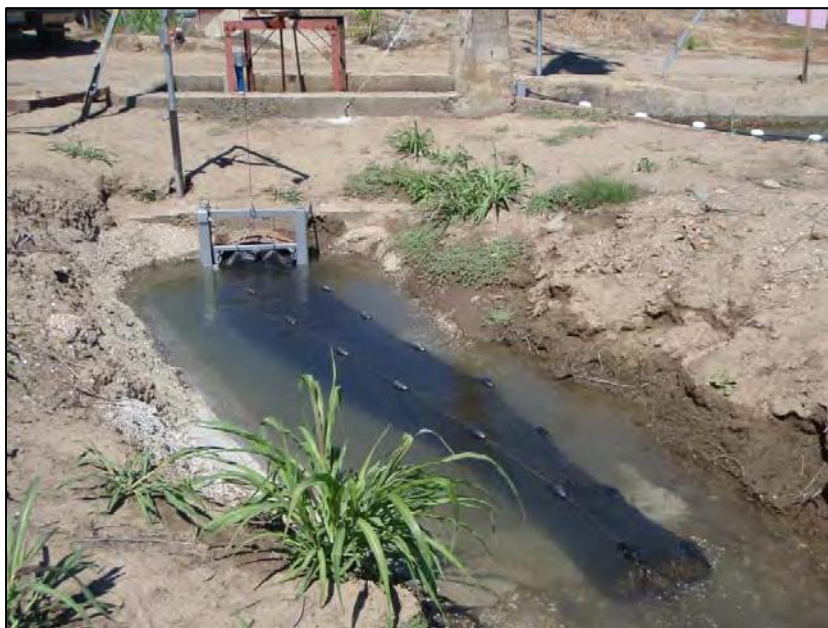
Figure 14. The fyke net and associated apparatus used to sample for fish entrainment in the Cranmore irregular-shaped concrete canal.

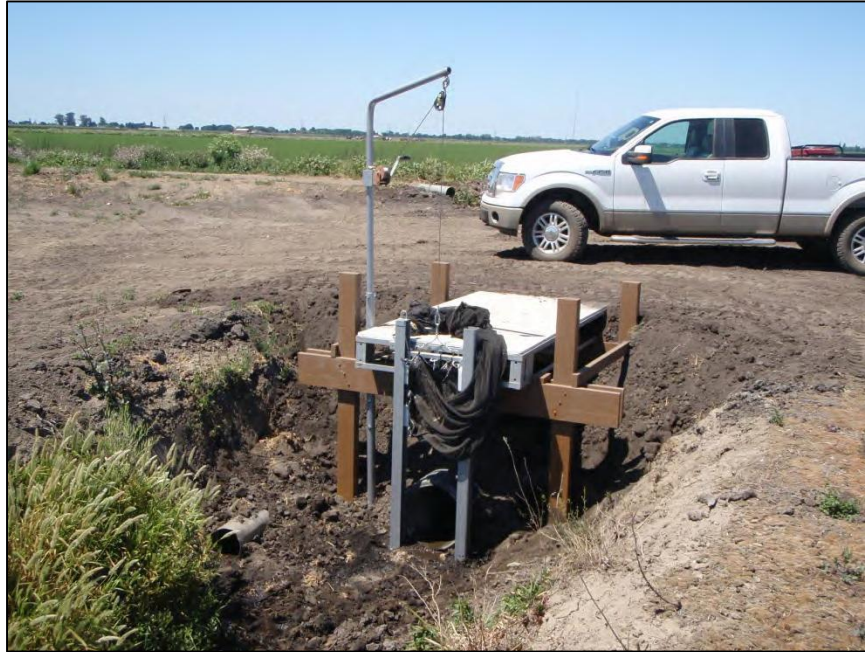
Figure 15. The fyke net, sampling platform, and associated apparatus used to sample for fish entrainment in the Sanchez east canal.

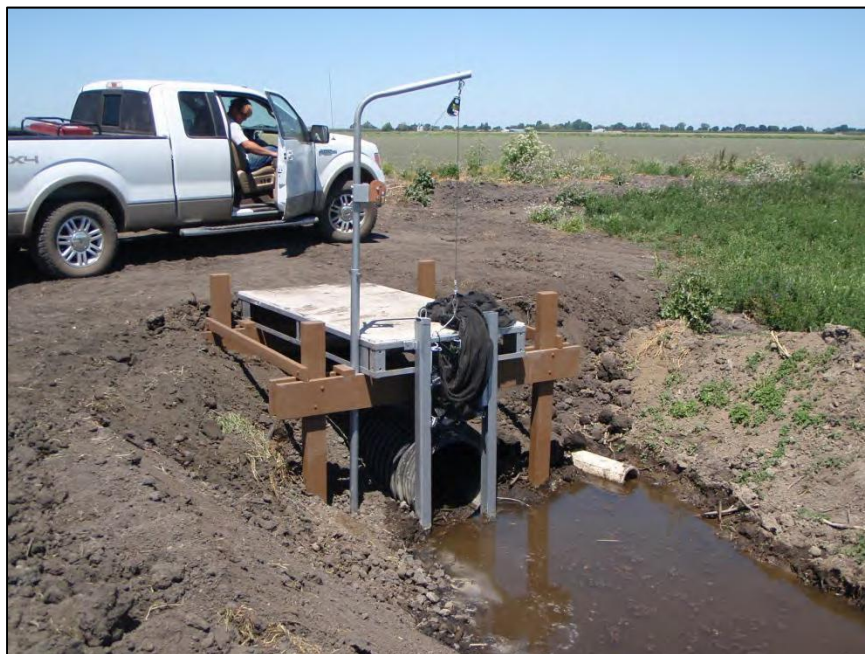
Figure 16. The fyke net, sampling platform, and associated apparatus used to sample for fish entrainment in the Sanchez west canal.

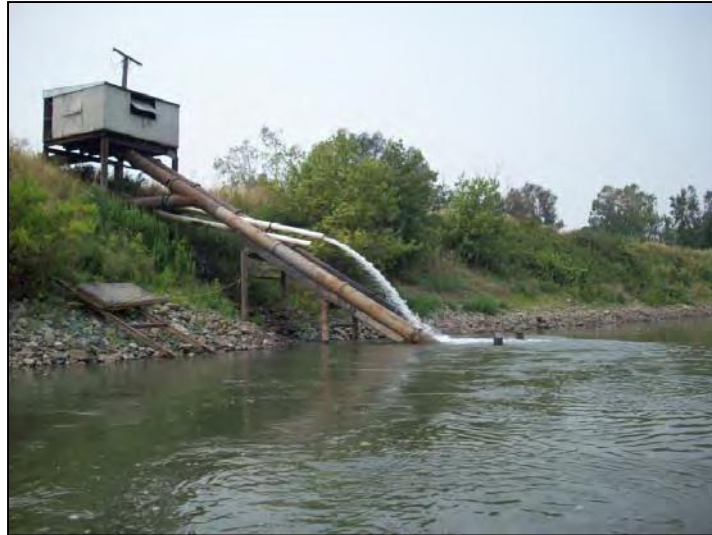
Figure 118. An example of excess flow at an unscreened diversion being diverted back into the Sacramento River.

As described below, some of the unscreened diversions on the Sacramento River possess discharge pipes back to the river. This circumstance is because many of the diversions do not have variable-speed water pumps. In these situations, additional pumped flow that is in excess of the irrigation needs at any particular time is diverted back into the river by way of a bypass pipe. An example visible above the river surface is shown in Figure 118. An example of the bypass valves for the two Sycamore intake pipes is shown in Figure 119. In many instances, the discharge pipe is beneath the river surface and, without close inspection or technical knowledge of the diversion, the return discharge pipe could be mistaken as an intake pipe. The significance of this condition is that actual pumped flow from the river is sometimes (and perhaps often) not the same as the flow entering the irrigation canals. However, fish are exposed to the actual pumped flow from the river but

may be diverted back into the river before entering the irrigation canal (i.e., the fish would be entrained into the pump intake but not entrained into the irrigation canal). The fish would likely experience physical injury or mortality after passage through the pump's impeller or the pipe system. There is also the potential for bypassed flows to unnaturally attract predatory fish at the site to feed on stressed or injured entrained fish routed back to the river. The timing and magnitude of bypassed flow back to the river may vary frequently during the irrigation season and, to our knowledge, daily records of those operations are not maintained. The resulting fish losses associated with bypassed flows could not be measured during this study and remain unknown.

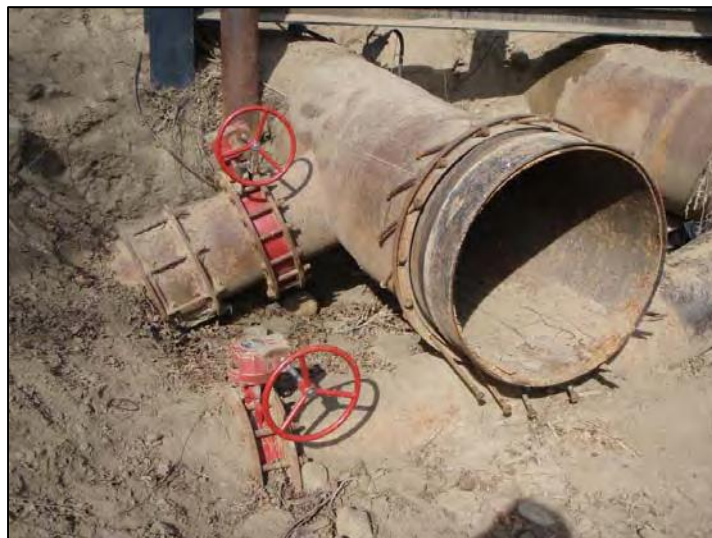
Figure 119. Flow bypass valves (red) at the Sycamore diversion. The two large-diameter pipes on the right lead to the Sycamore canal through a levee. Each pipe has a separate flow bypass valve on the left that can be used to route excess pumped flow back to the Sacramento River. The left intake pipe is disconnected for pump maintenance.

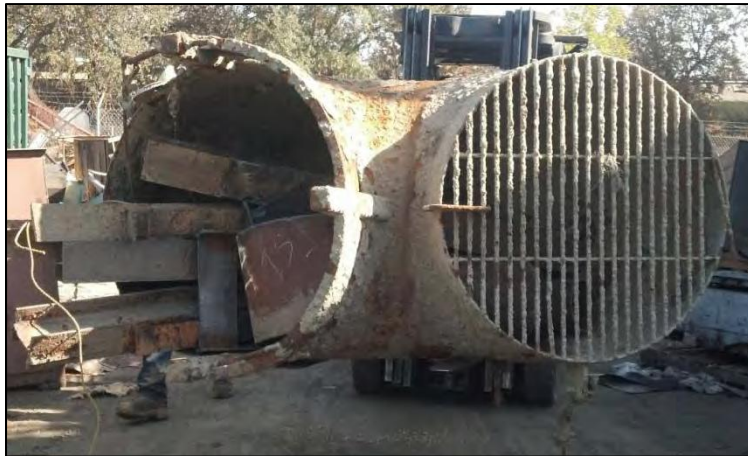
Figure 120. Trash racks (bars) on the Alamo diversion intake pipe shown on its side. Picture was taken after removal from the river prior to installation of an ISI fish screen. Note the individual's boot at the lower left portion of the picture for size reference. Prior to removal, this intake was positioned upwards such that the intake opening and trash racks were horizontal and the river flow went over the top of the intake opening. Photo by ISI.

An important variable that can affect fish entrainment is the physical characteristics of the intakes (e.g., presence or absence of a trash rack over the diversion intake) (Figure 120). Although physical internal measurements of the intakes were not part of this study, an interview with Russ Berry, Jr. of Intake Screens, Inc. (ISI) provided useful information. Mr. Berry SCUBA dove at most of the unscreened diversion intakes monitored during this study prior to installation of ISI's fish screens. Based on a combination of Mr. Berry's notes and memory, the following provides relevant information on additional physical factors that could have had a significant effect on fish entrainment for some of the diversion sites. However, it is important to emphasize that detailed measurements of each intake were not performed as part of this study and, therefore, no definitive conclusions can be made concerning the effects of variable structure intakes on fish entrainment. The following discussion is provided only to call attention to some general features of the structures and to recommend that future studies should examine potential effects of intake configurations on fish entrainment.

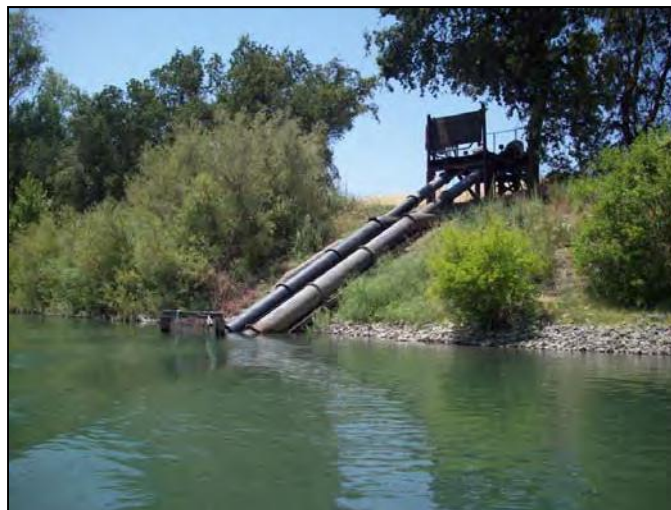
Appendix Figure 2. The Sycamore pump intakes looking in a downstream direction.

Based on in-river surveys conducted during the summer of 2008, the two Sycamore 30-inch diameter pipe intakes enter the water at a 30-degree angle (Appendix Figure 2) (Appendix Table 1). At the time of the survey on July 16, 2008, the water depth at the pipe intakes was 11 feet with the intakes positioned one foot above the cobble riverbed, 30 feet from the river's edge, and flow was unidirectional. Rearing habitat for juvenile salmon was characterized as poor and predatory fish habitat was classified as fair (Vogel 2008c). Additional features of the site are provided in Appendix Table 1.

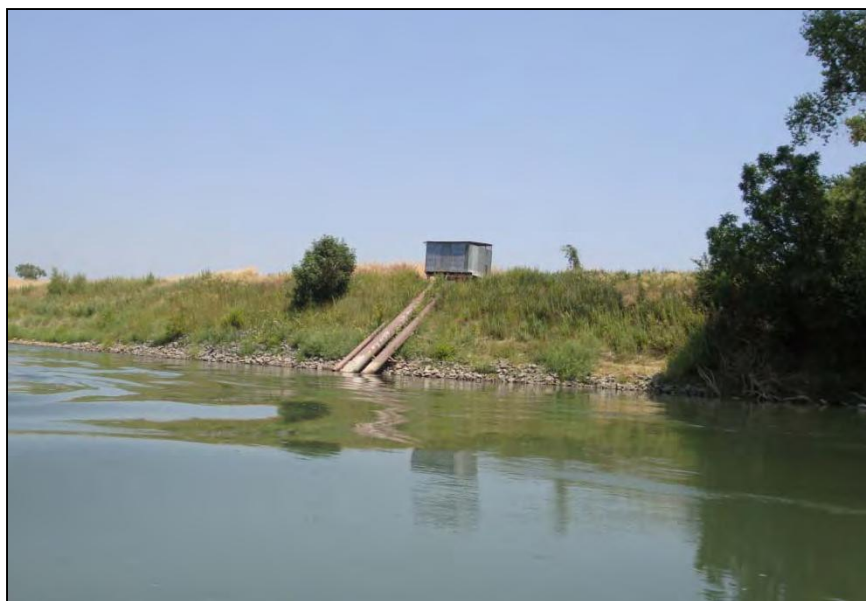
Appendix Figure 9. The River Garden Farms No. 2 pump intakes looking in a downstream direction.

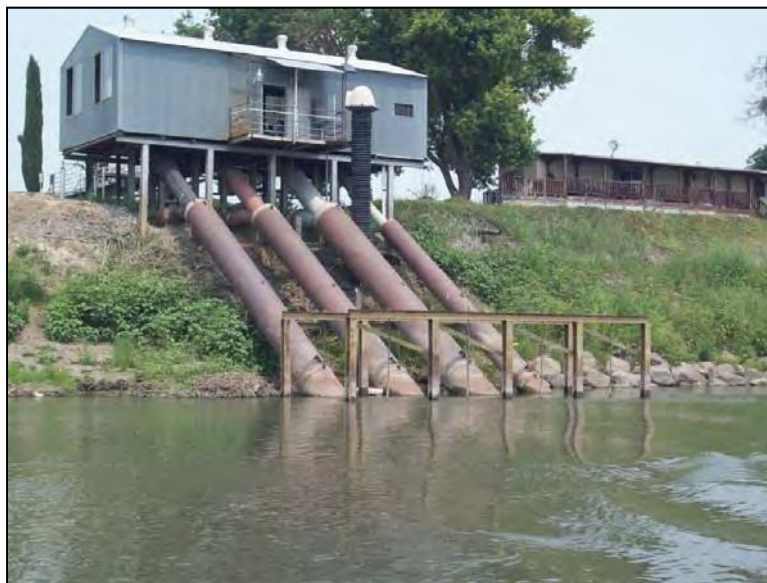
Appendix Figure 16. The State Ranch pump station intakes looking in a downstream direction.

Based on in-river surveys conducted during the summer of 2008, the four State Ranch intake pipe diameters, in an upstream to downstream direction, are 36 inches, 36 inches, 42 inches, and 29 inches and enter the water at a 33-degree angle (Appendix Figure 16) (Appendix Table 3). At the time of the survey on June 25, 2008, the water depth at the pipe intakes was 13 feet with the intakes positioned five feet above the sand riverbed, 30 feet from the river's edge, and flow was unidirectional. Rearing habitat for juvenile salmon was characterized as poor and predatory fish habitat was classified as good (Vogel 2008c). Additional features of the site are provided in Appendix Table 3.

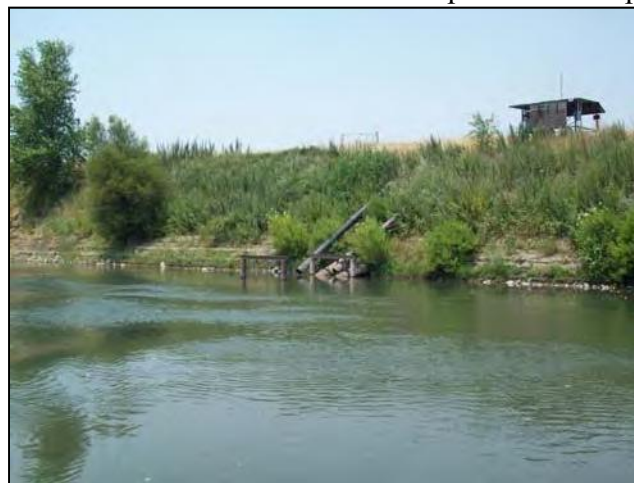
Appendix Figure 23. The South Steiner pump station intakes looking in a downstream direction.

Based on in-river surveys conducted during the summer of 2008, the 24-inch diameter South Steiner pipe intakes enter the water at 20-degree and 25-degree angles (Appendix Figure 23) (Appendix Table 4). At the time of the survey on July 8, 2008, the water depth at the pipe intakes was 13-14 feet with the intakes positioned two feet above the cobble and sand riverbed, 25 feet from the river's edge, and flow in the vicinity of the intake was slow and in a back eddy. Rearing habitat for juvenile salmon was characterized as poor and predatory fish habitat was classified as fair (Vogel 2008c). The U.S. Army Corps of Engineers recently implemented an upstream levee improvement project near the diversion intake (Dan Meier, USFWS, pers. comm.). Water district staff or other individuals familiar with that project will be contacted prior to the final report to determine if the project may have significantly changed the site characteristics since the 2008 river surveys. Additional features of the site are provided in Appendix Table 4.

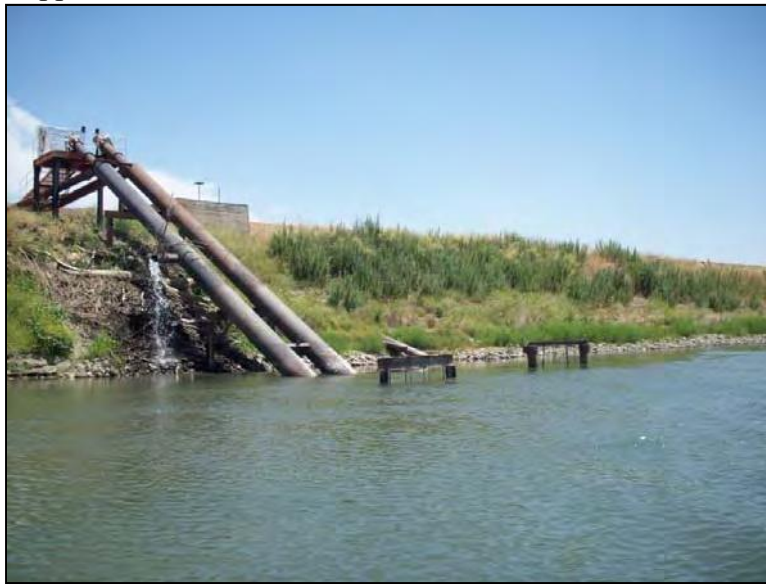
Appendix Figure 30. The Oji pump station intakes looking in a downstream direction.

Based on in-river surveys conducted during the summer of 2008, the 30-inch diameter Oji pipe intakes enter the water at 30-degree angle (Appendix Figure 30) (Appendix Table 5). At the time of the survey on June 30, 2008, the water depth at the pipe intakes was 14 feet with the intakes positioned three feet above the sand and cobble riverbed, 30 feet from the river's edge, and flow in the vicinity of the intake was swift and unidirectional. Rearing habitat for juvenile salmon was characterized as poor and predatory fish habitat was classified as fair (Vogel 2008c). Additional features of the site are provided in Appendix Table 5.

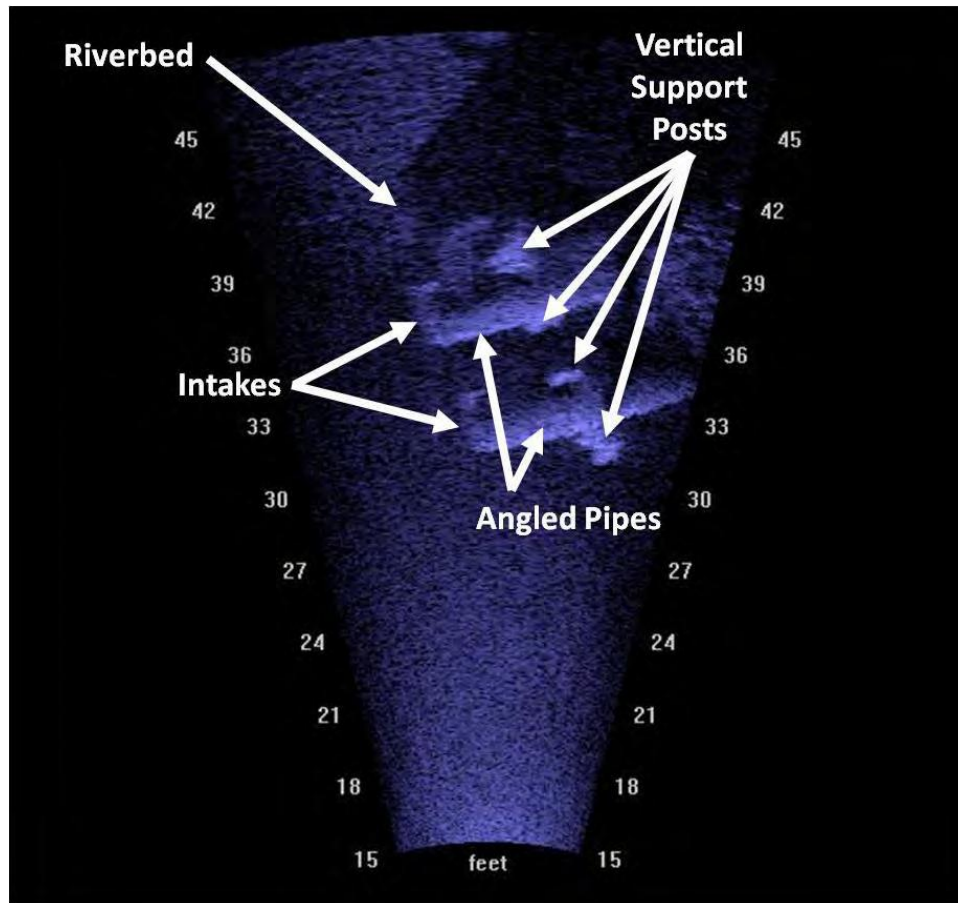
Appendix Figure 31. DIDSON™ still image of the two angled pipe intakes at the Oji pump station (looking upstream). Image taken on July 17, 2008.

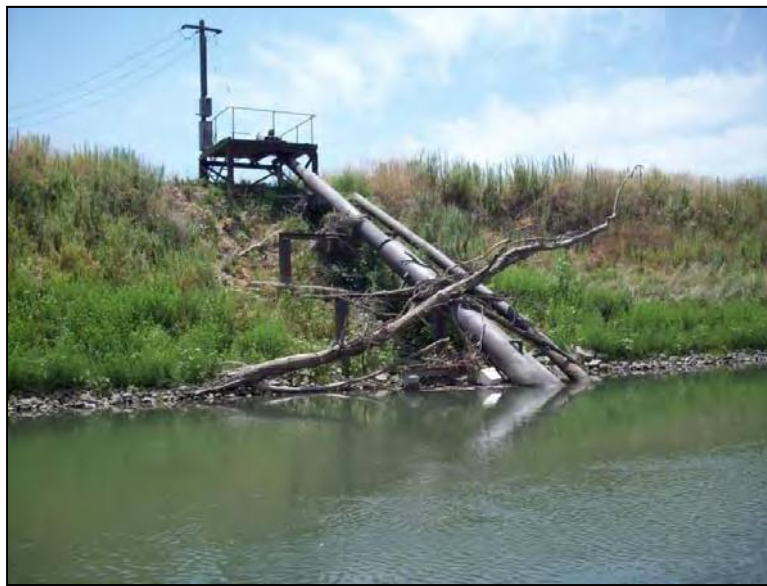
Appendix Figure 37. The Windswept pump station intake looking in a downstream direction\.

Based on in-river surveys conducted during the summer of 2008, the 24-inch diameter Windswept pipe intake enters the water at 30-degree angle (Appendix Figure 37) (Appendix Table 6). At the time of the survey on June 30, 2008, the water depth at the pipe intake was 12 feet with the intakes positioned three feet above the cobble riverbed and flow in the vicinity of the intake was swift and unidirectional. Rearing habitat for juvenile salmon was characterized as poor and predatory fish habitat was classified as fair (Vogel 2008c). Additional features of the site are provided in Appendix Table 6.

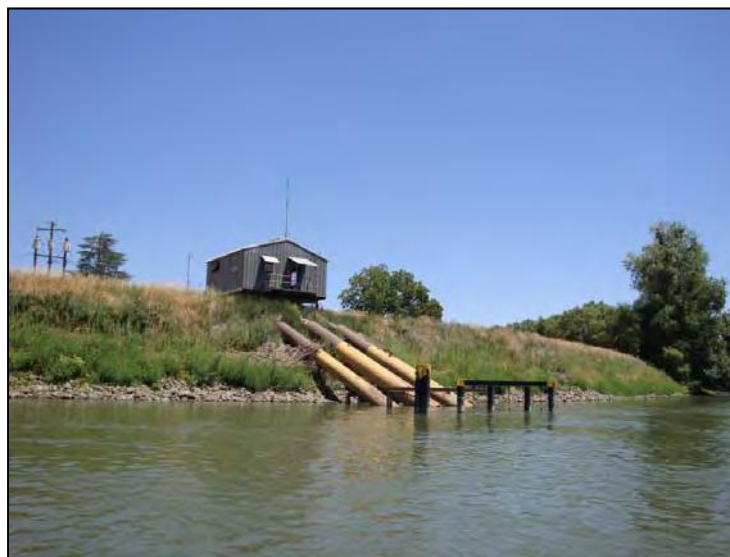
Appendix Figure 44. The Portuguese Bend pump station intakes looking in a downstream direction.

Based on in-river surveys conducted during the summer of 2008, the four Portuguese Bend intake pipe diameters, in an upstream to downstream direction, are 36 inches, 46 inches, 40 inches, and 22 inches and enter the water at a 20-degree angle (Appendix Figure 44) (Appendix Table 7). At the time of the survey on June 19, 2008, the water depth at the pipe intakes was 12 feet with the intakes positioned three feet above the riprap substrate riverbed, 33 feet from the river's edge, and flow was swift and unidirectional. Rearing habitat for juvenile salmon was characterized as poor and predatory fish habitat was classified as good (Vogel 2008c). Additional features of the site are provided in Appendix Table 7.

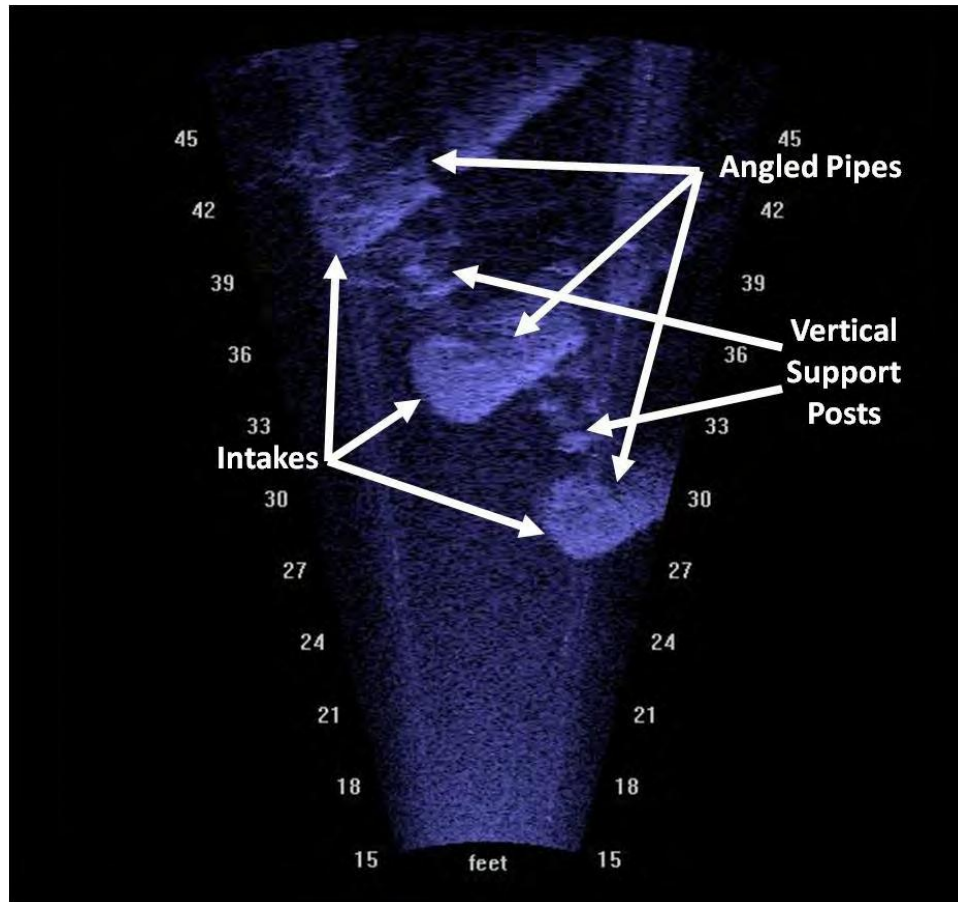
Appendix Figure 45. DIDSON™ still image of the angled pipe intakes at the Portuguese Bend pump station (looking upstream). Woody debris at the downstream end of the pipe intakes is not shown. Image taken on July 3, 2008.

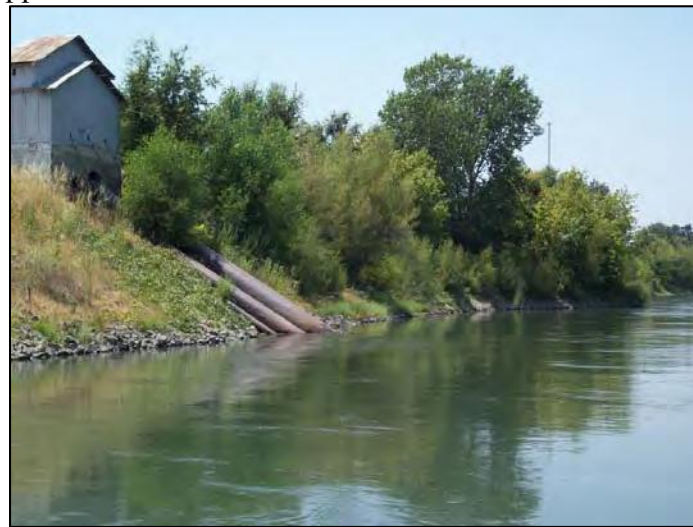
Appendix Figure 51. The Alamo pump intakes looking in an upstream direction.

Based on in-river surveys conducted during the summer of 2008, the two Alamo 42-inch and 26-inch diameter pipe intakes enter the water at a 30-degree angle (Appendix Figure 51) (Appendix Table 8). At the time of the survey on July 14, 2008, the water depth at the pipe intakes was 13 feet with the intakes positioned three feet above the cobble and sand riverbed, 25 and 30 feet from the river's edge, respectively, and flow was swift and unidirectional. Rearing habitat for juvenile salmon was characterized as poor and predatory fish habitat was classified as fair (Vogel 2008c). Additional features of the site are provided in Appendix Table 8.

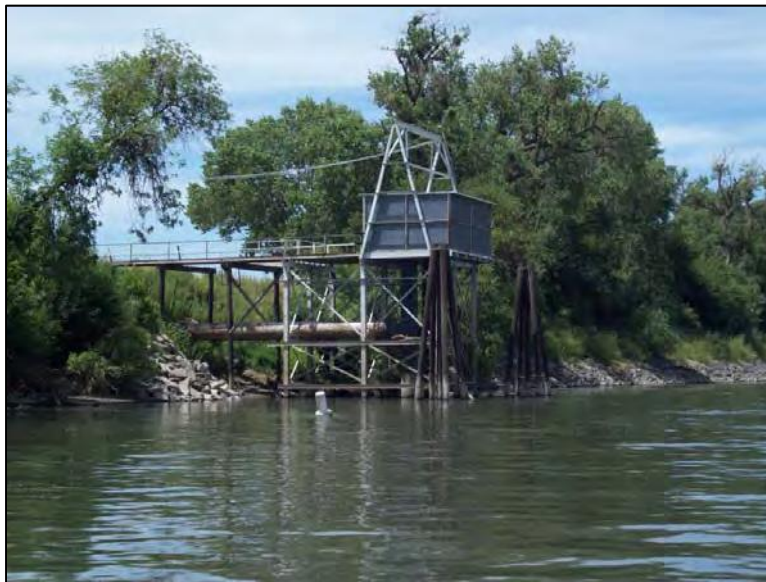
Appendix Figure 58. The Townsite pump intakes looking in an upstream direction.

Based on in-river surveys conducted during the summer of 2008, the Townsite two 34-inch diameter and one 20-inch diameter pipe intakes enter the water vertically at a 90-degree angle (Appendix Figure 58) (Appendix Table 9). At the time of the survey on June 19, 2008, the water depth at the pipe intakes was 8 feet with the intakes positioned ranging from one to three feet above the silt riverbed, 33 feet from the river's edge, and flow was swift and unidirectional. Rearing habitat for juvenile salmon was characterized as poor and predatory fish habitat was classified as good (Vogel 2008c). Additional features of the site are provided in Appendix Table 9.

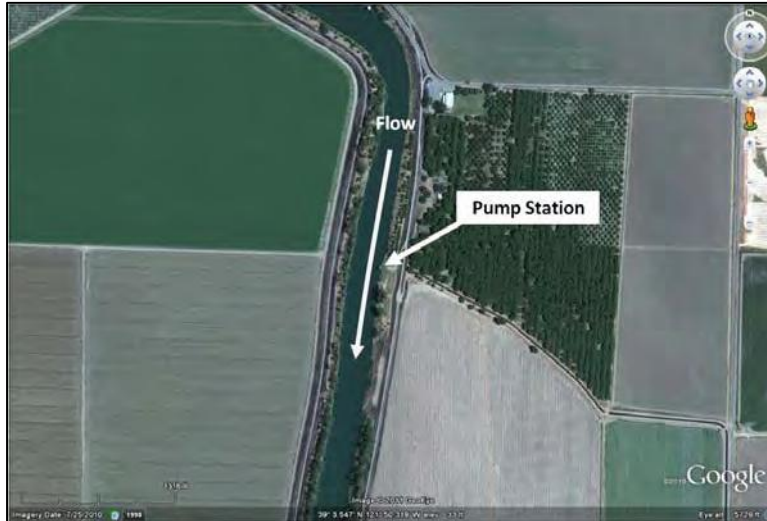
Appendix Figure 64. Location of the Tisdale pump station on the Sacramento River.

The Tisdale pump station intake is located on the left side of the river (facing downstream) on a straight reach of the river just downstream of a right river bend (Appendix Figure 64).

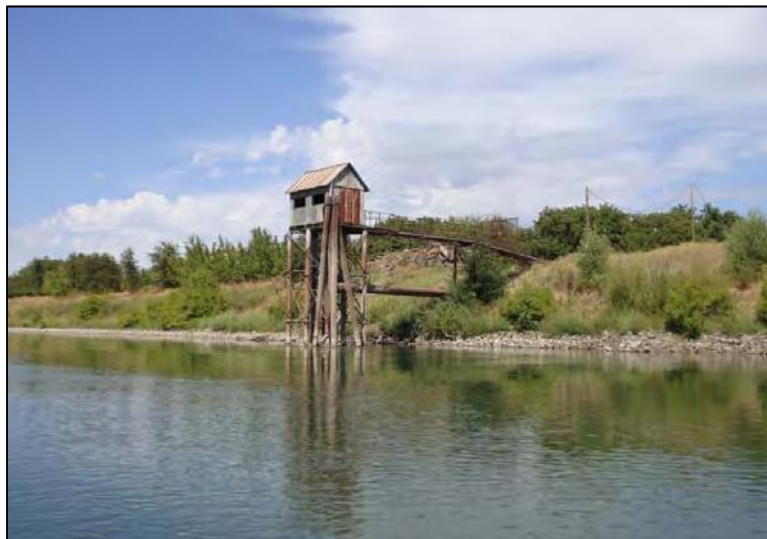
Appendix Figure 65. The Tisdale pump intakes looking in an upstream direction.

Based on in-river surveys conducted during the summer of 2008, the two Tisdale 24-inch and 18-inch diameter pipe intakes enter the water vertically at a 90-degree angle (Appendix Figure 65) (Appendix Table 10). At the time of the survey on July 10, 2008, the water depth at the pipe intakes was 13 feet with the intakes positioned five and four feet, respectively, above the riprap and silt riverbed, 30 feet from the river's edge, and flow was swift and unidirectional. Rearing habitat for juvenile salmon was characterized as fair and predatory fish habitat was classified as good (Vogel 2008c). Additional features of the site are provided in Appendix Table 10.

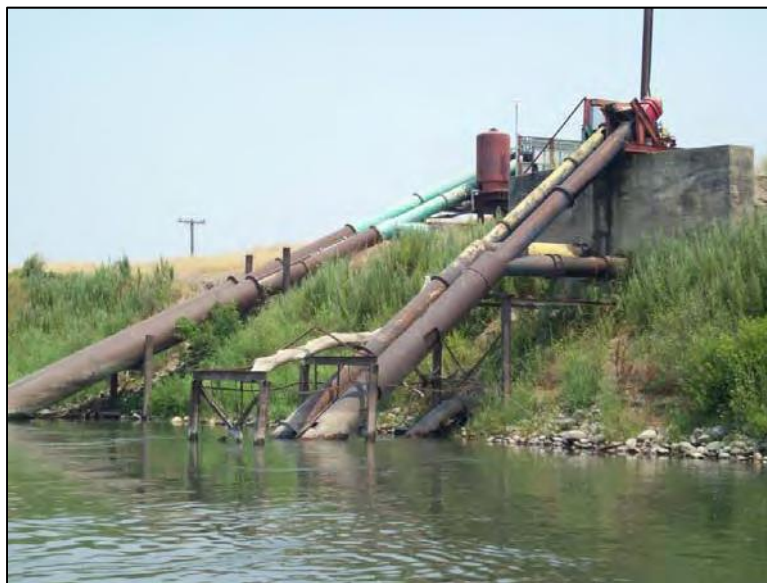
Appendix Figure 72. The Cranmore pump intakes (foreground) looking in an upstream direction.

Based on in-river surveys conducted during the summer of 2008, the two Cranmore 36-inch and 26-inch diameter pipe intakes enter the water at a 45-degree angle (Appendix Figure 72) (Appendix Table 11). At the time of the survey on July 7, 2008, the water depth at the pipe intakes was 17 feet with the intakes positioned two feet above the riprap and sand riverbed, 30 feet from the river's edge, and flow was swift and unidirectional. Rearing habitat for juvenile salmon was characterized as poor and predatory fish habitat was classified as fair (Vogel 2008c). Additional features of the site are provided in Appendix Table 11.

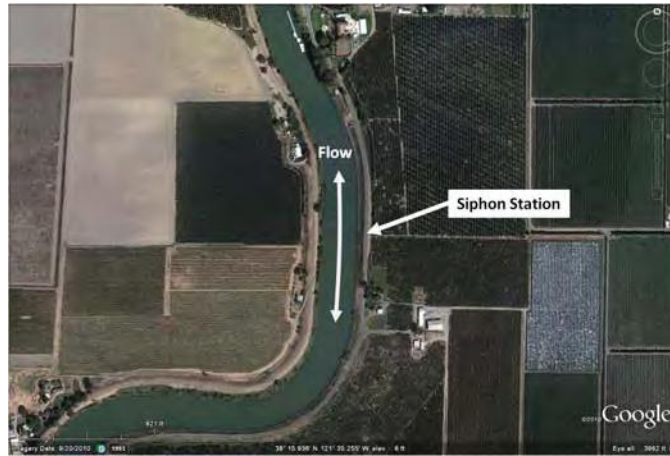
Appendix Figure 78. Location of the Sanchez siphon station on Steamboat Slough.

The Sanchez siphon station intake is located in Steamboat Slough on the east side of the slough on a relatively straight reach but generally just after an outside bend regardless of ebb or flood tide conditions (Appendix Figure 78). Flow past the site occurs in both directions due to tidal influence. In-channel measurements and features of the Sanchez siphon station were not included in the 2008 river survey but a similar-type survey was conducted on December 10, 2012.
