**Reconnaissance-Level Assessment of  
Channel Change and Spawning Habitat  
on the  
Stanislaus River Below Goodwin Dam**

*Report to the  
U.S. Fish and Wildlife Service  
Sacramento, CA*

March 22, 2001

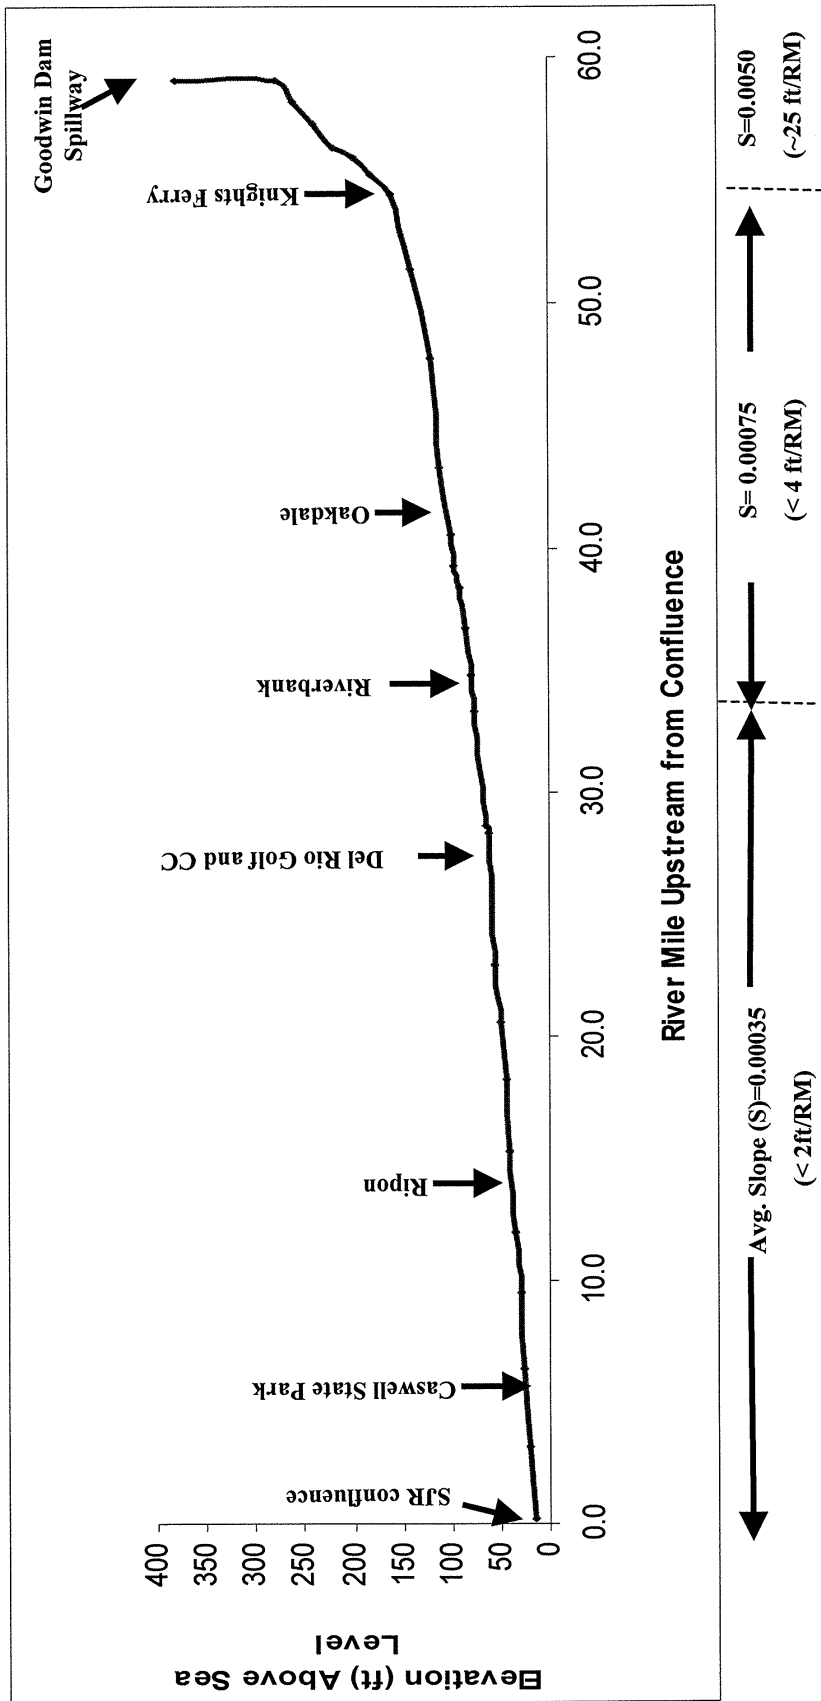
**Figure 3.4: Lower Stanislaus River Longitudinal Profile** (vertically exaggerated). Using the elevations and river mileage from USGS 1: 24,000 (7.5 min) topographic maps, we estimate average slopes from Goodwin Dam to the confluence with the San Joaquin River. The lowest reach, from the confluence to Riverbank, is composed of Holocene alluvium deposits and has an average gradient less than 2 ft/river mile. The reach between Riverbank and Knights Ferry descends an average of 4 ft/RM with Riverbank formation materials also present. From Knights Ferry to Goodwin Dam, slopes average 25 ft/RM with Gopher Ridge volcanics present in the uppermost reach. (Geology summarized from Wagner et al. Geologic Map of SF-San Jose Quadrangle).

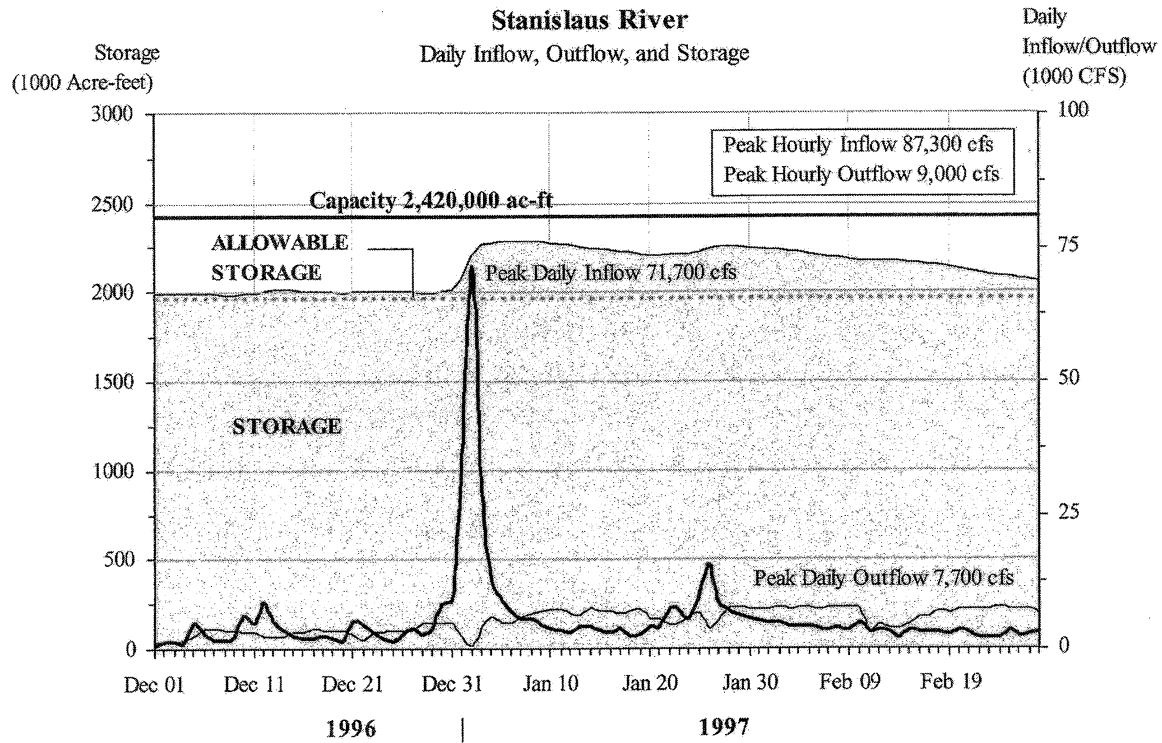
**Figure 3.6: Performance of New Melones Dam in the January 1997 Floods.** This 1997 flood hydrograph from the USACE Post Flood Assessment presents daily time series data for hydrologic conditions and reservoir operations during the 1997 rain flood event (USACE 1999). Inflow (cfs) and outflow (cfs) from New Melones dam is plotted for a three month period around the 1996-1997 flood event. Note that even though 71,700 cfs was flowing into New Melones, its capacity of 2.4 maf (over 200% of average annual unimpaired runoff) allowed for a maximum release of 7,700 cfs. Flow releases are limited to less than 8,000 cfs in the Lower Stanislaus River. (Source: USACE Post-Flood Assessment, March 1999, Appendix E).

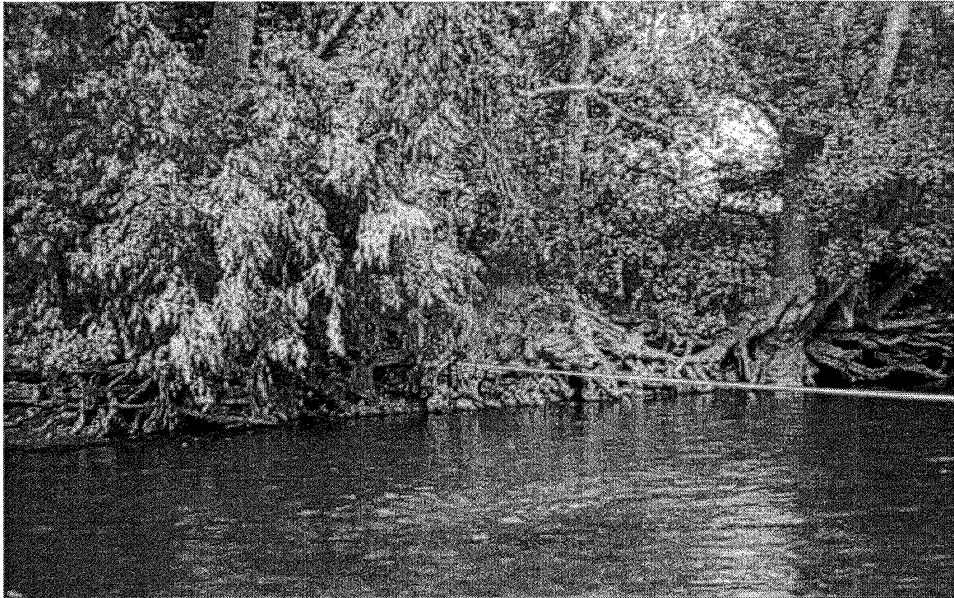
**Figure 5.5: Root Crown Exposure at R78, Stanislaus River.** (RM 40: 375cfs). Note the vegetation encroachment and extent of root wad exposure at this site, indicating channel incision and erosional processes (Photo, K. Schneider, 10/27/99).

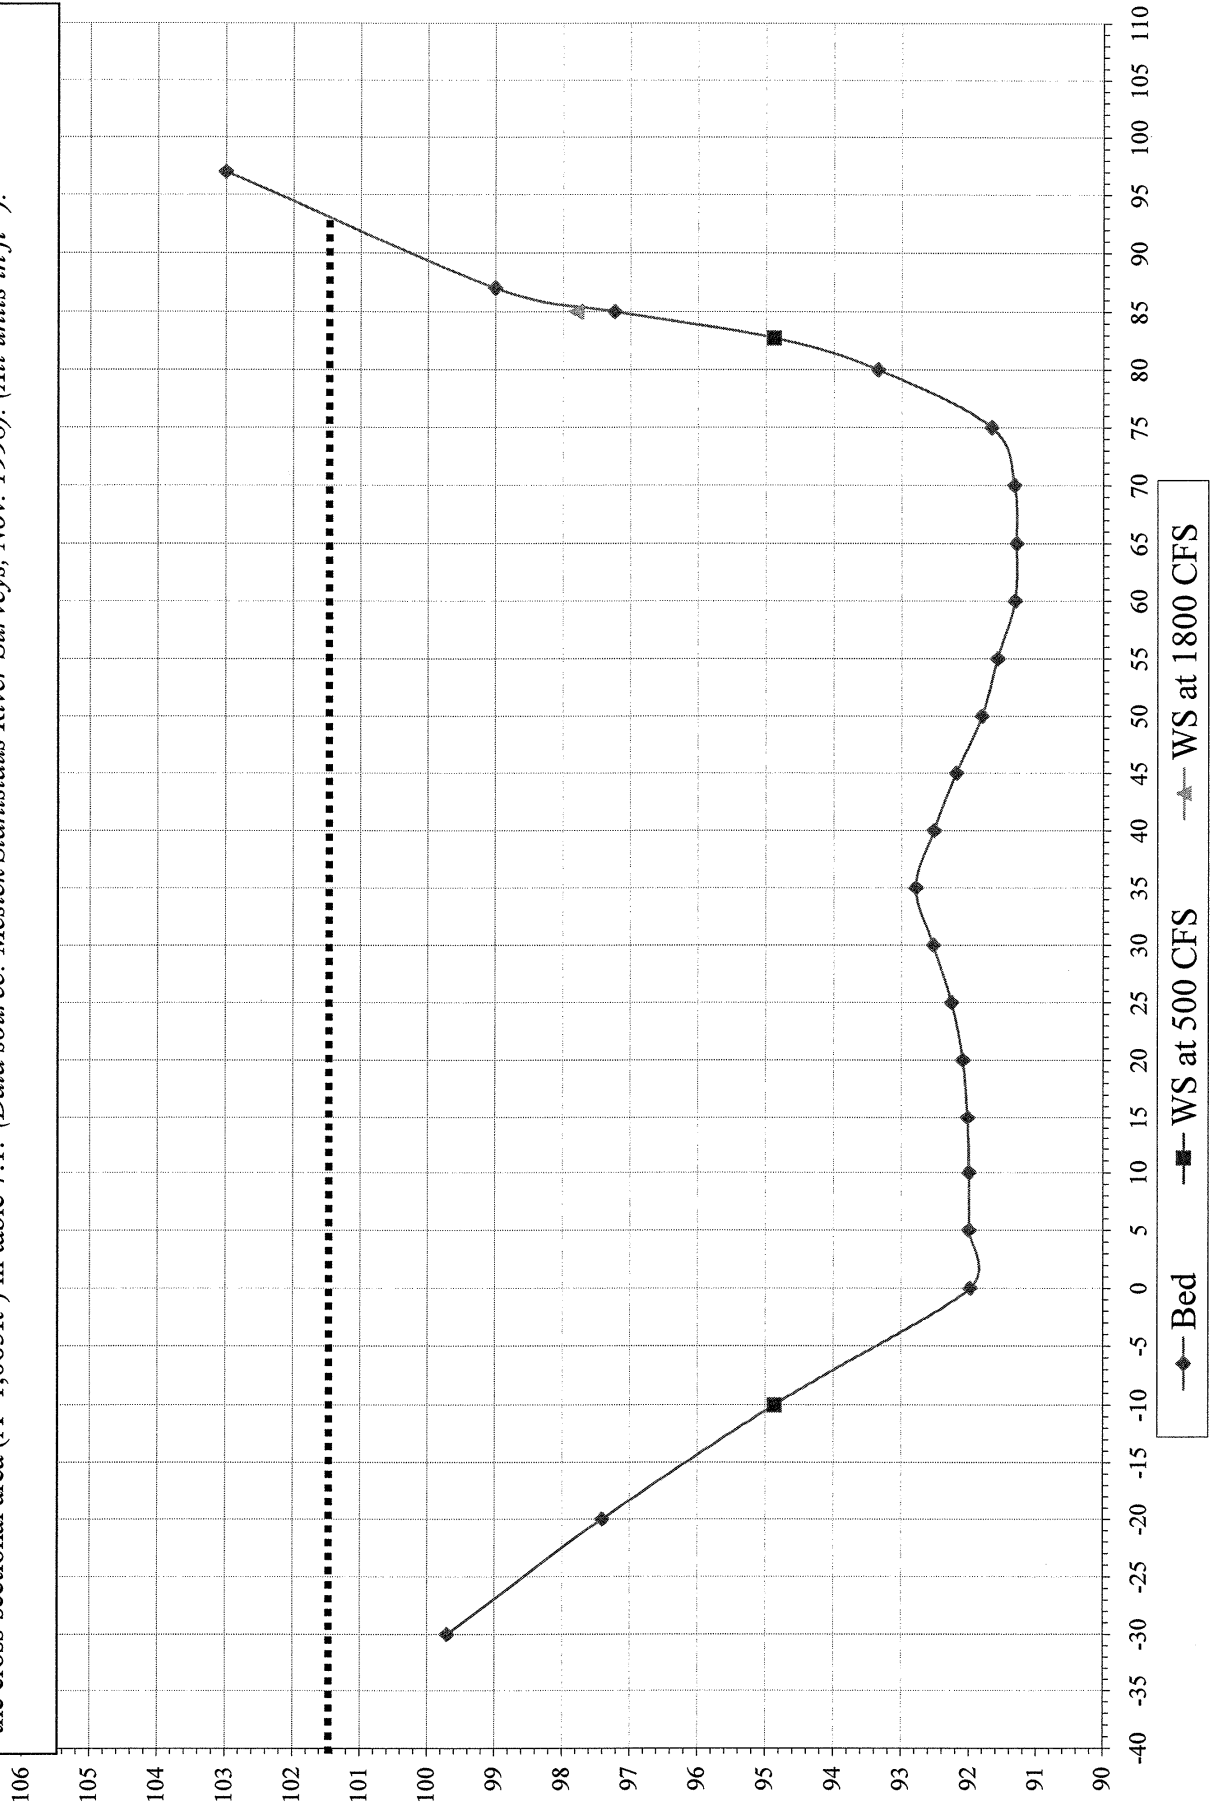
**Cross Section at R78 - (Moderate Crested Riffle).** Calculated depth necessary to mobilize the  $D_{50}$  indicated ( $d=10.3\text{ft}$ ) and used to estimate the cross-sectional area ( $A\sim 1,065\text{ft}^2$ ) in table 7.1. (Data source: *Mesick Stanislaus River Surveys, Nov. 1998*). (All units in  $\text{ft}^2$ ).
